## Galerie de Peintures

Location : Château de Chantilly

Package : Glazed roof

Scope : Technical design and assistance for construction site supervision

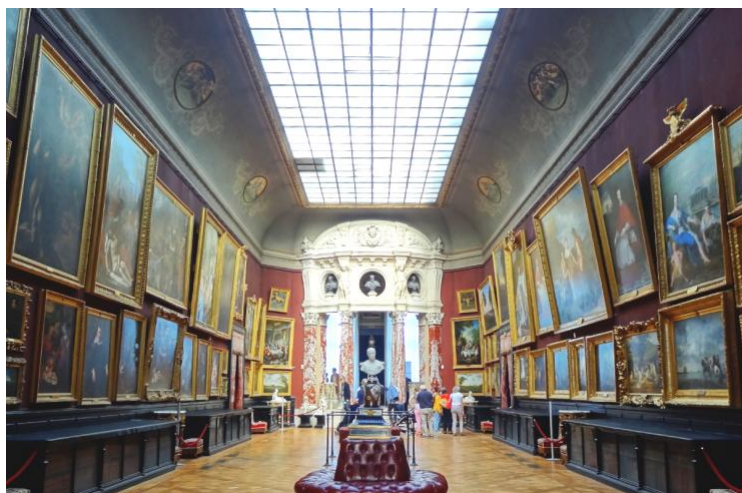
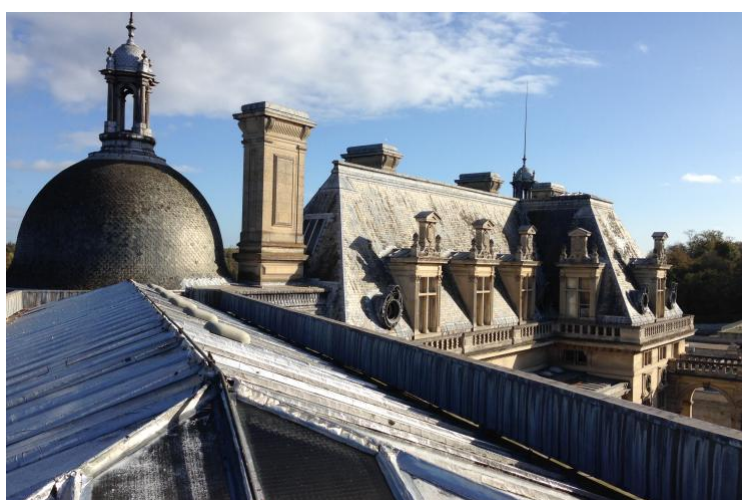
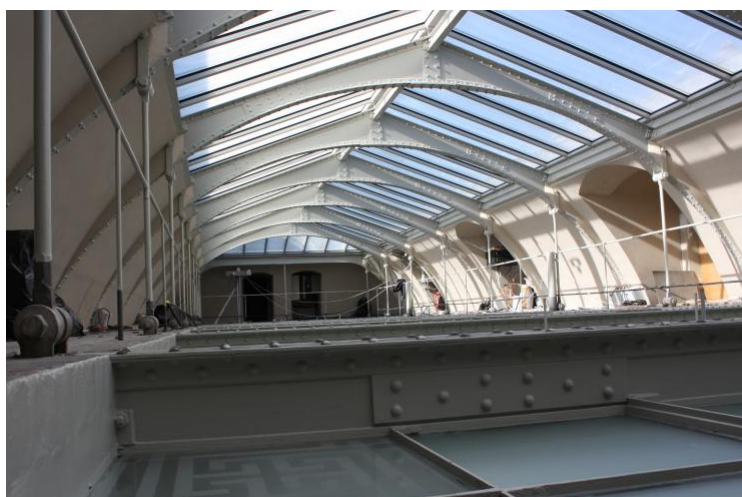
The glass roof consists of a glazed structure supported by a metal framework, while the ceiling incorporates glass panels held by a metallic structure between the trusses. The framework features riveted steel arches. T/E/S/S is responsible for the restoration of the glazed ceiling and the replacement of the roofing system. As the structure is classified as a Historic Monument, the technical challenge of the project is to reconcile restoration, conservation of the architectural integrity, and the reuse of original materials. Additionally, the objective is to restore the quality of natural light within the gallery, improve the thermal performance of the glazing, and facilitate future maintenance.

The ceiling's structure consists of an intricate assembly of steel angle bars supporting the glazing. The glass panels are frosted at the center and engraved with a decorative frieze pattern around the edges. The restoration includes the lamination of the historic decorated glass panels and the renewal of their supporting framework to enhance visitor protection. Furthermore, the ceiling incorporates rack-and-pinion opening mechanisms for gallery ventilation, which are being restored to full operation.

The overhead glass roof is being entirely replaced by a structure similar in size to the existing framework. The primary framework supporting the glazing is undergoing restoration. The new infill consists of double glazing with integrated solar and thermal control layers. Additionally, a silk-screened pattern replicates the original striated glass design, which also helps reduce solar heat gain in the attic space above the gallery. The renewed glass roof provides significantly improved waterproofing and thermal performance.
